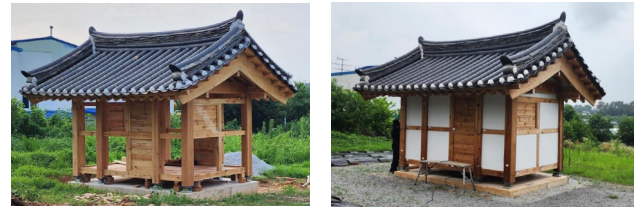
a) 2024.09

b) 2025.07

Fig. 9. Outdoor experimental model

Fig. 9

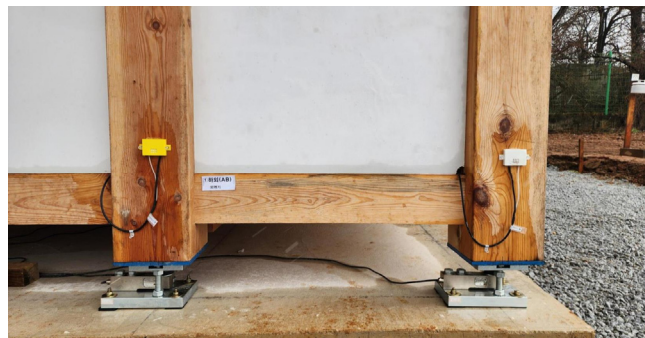
Fig. 12. Damage to the lower part of the column

Fig. 12
